**CHERRY CREEK RESERVOIR
DESTRATIFICATION SYSTEM**

**OPERATION AND MAINTENANCE
ANNUAL REPORT
2023**

January 2024

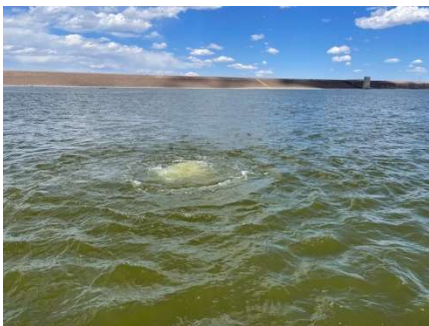
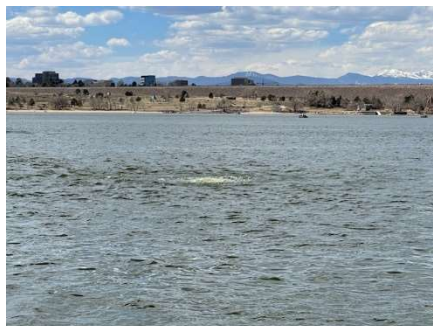
- Started the compressor at 12:30 pm then proceeded with Erin Stewart to inspect the aerator plumes by boat.
- Found two aerators out of order and established their locations by GPS to forward to B&RW for repair.
- Blair Wacha of B&RW was contacted and related to me that he would be out early morning on April 17 to repair the faulty aerators.
- Finished our inspection of the system and shut the compressor off at 1:45pm.

Broken aerator

- B&RW finished its repair of the two identified aerators and a third that he had found.
- Blair called me to give details of the repairs, all of which were situations where the plastic flow regulators had been blown out of place by back-pressure, probably caused by too rapid a shutdown during shutdown last year.
- We will be revising our shutdown procedures for the end of the operating season.

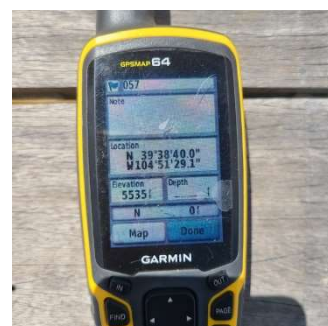
Marking broken aerator by GPS

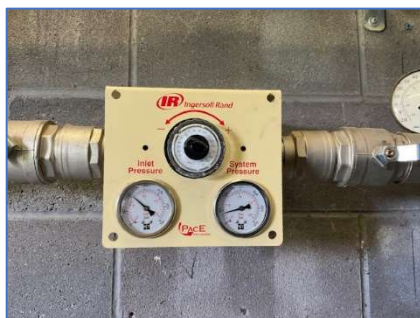
- Made a spot inspection of the compressor and visual inspection of the aeration pattern in the reservoir. Found the aeration pattern in the reservoir satisfactory, the compressor running at its 100 psi satisfactorily, but the pressure reducer gauge was showing only 45psi. Figuring that it had been adjusted during the piping repair, I adjusted it back up to 55 psi. Everything was good.

Initial pressure at 45 psi

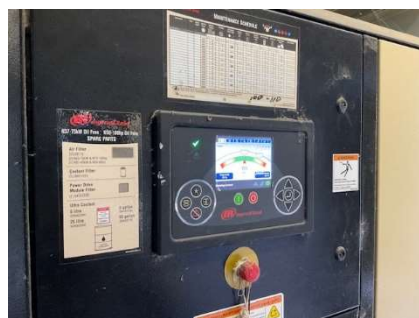
Compressor pressure at 100 psi

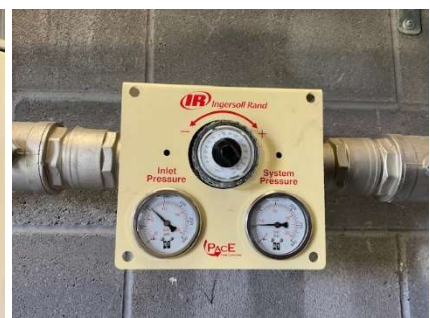
Reset pressure to 55 psi

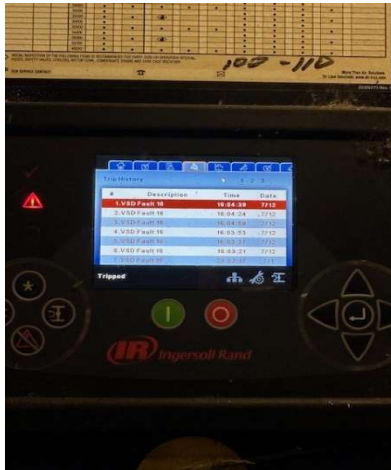
- On 7/13/23 at 8:15 I performed a random visual inspection of the diffuser pattern on the reservoir and found that was no pattern, meaning that no air was getting to the aerators in the reservoir.
- Upon an inspection of the compressor, I found that it was off, with a fault indication reading "VSD Fault 16" at 4:18 pm, the day before, 7/12/23. This meant that the compressor had been off for about a day and a half.
- I called Jeff Handley at Ingersoll Rand, who indicated that IR had just received a fault notice, and that it was safe to restart the compressor, which was done.
- The compressor started immediately with no issue. Jeff said the fault had been caused by a voltage drop, probably from local area heavy air conditioning usage, or possibly caused by an electrical contractor known to have been working nearby.

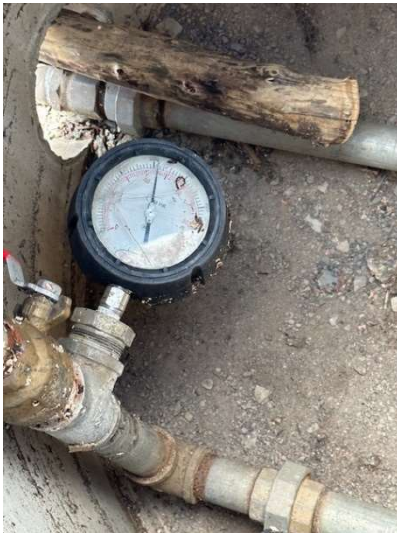
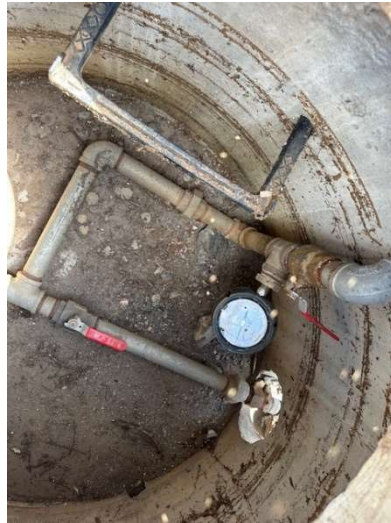
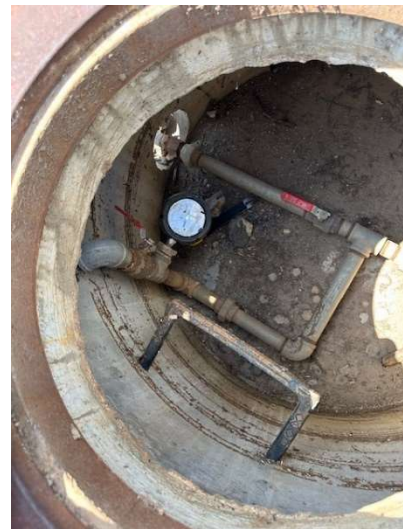
- I made another spot inspection. Reservoir aeration pattern was satisfactory, but discharge pressure was down to 50 psi. Pressure was adjusted to 55 psi. All else looked good. I checked aeration manholes for flood damage. Except for a piece of driftwood that floated into one of the manholes, there was little evidence that reservoir high flood levels had affected the manholes or the aeration piping at all, and there was definitely no damage.

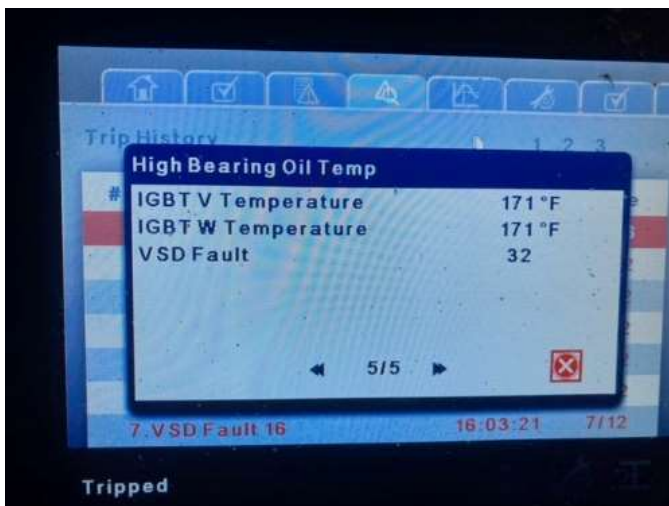
- Even though out of the country, I received an alarm by text message from the newly implemented RMS indicating that the compressor had shut down due to excessive bearing temperature. When I immediately called Ingersoll Rand, they said that they had received the same alarm and had someone already on it.
- The compressor had shut down because of excessive oil temperature caused by excessive dust build-up on the oil cooler. IR cleaned the oil cooler, and had the compressor back on line in 3 hours and 15 minutes from the time of the shutdown, substantiating the value of setting up the RMS process.

Trip notification

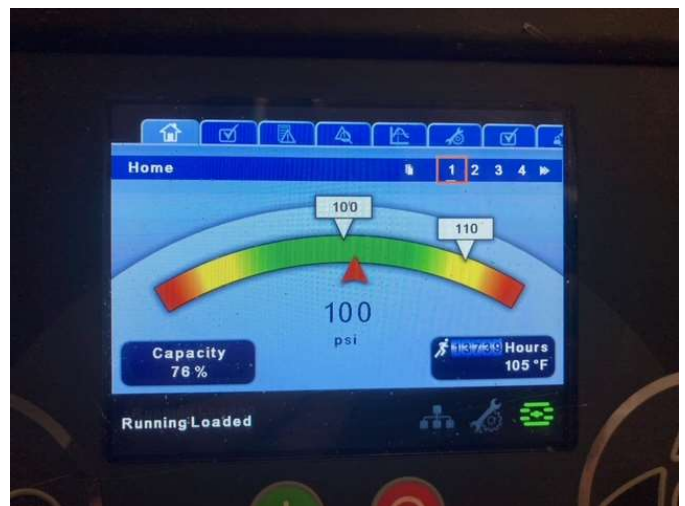
Compressor back in operation

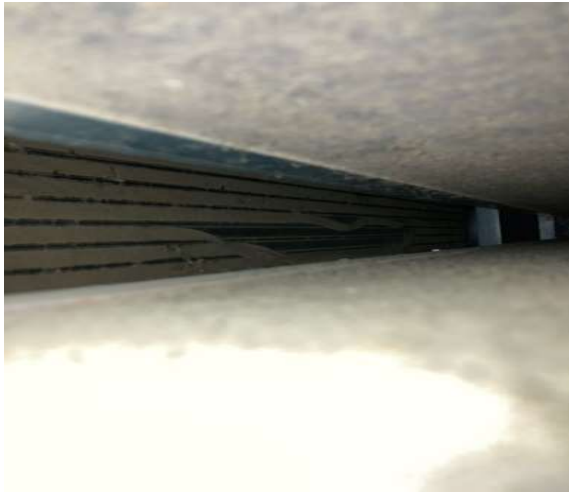
Dust buildup on the oil cooler

- To prevent the compressor oil coolers from clogging with dust and overheating, as occurred on August 21, to have Ingersoll Rand (IR) clean compressor coolers in April and in August, in between their three current contracted maintenance dates to minimize the chances of another high temperature shutdown. Jeff Handley has already quoted that to add this maintenance to their current contract would cost an additional \$1,750 and they are ready to implement this at any time.

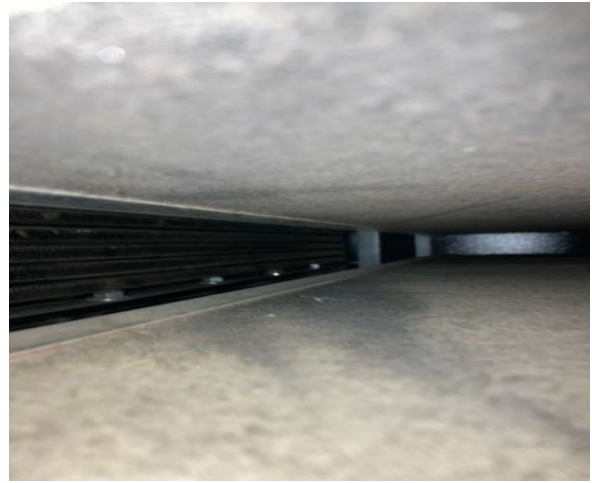
Oil cooler after cleaning

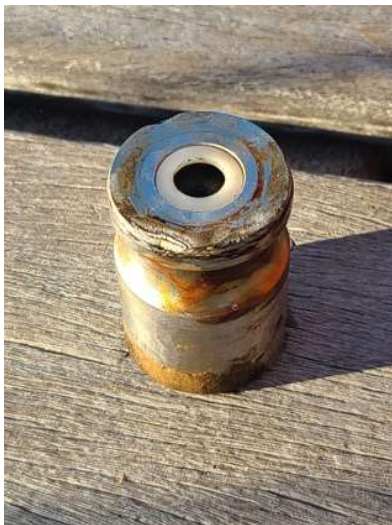
Corroded flow regulator

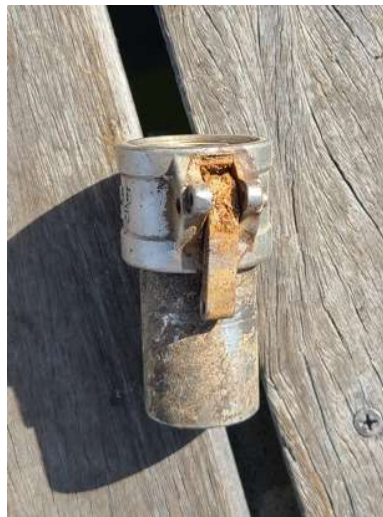
Corroded cam lever

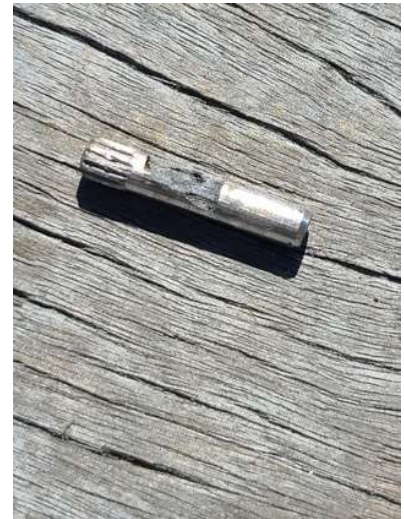
Corroded pin

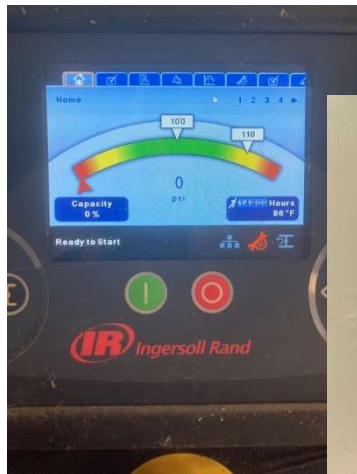
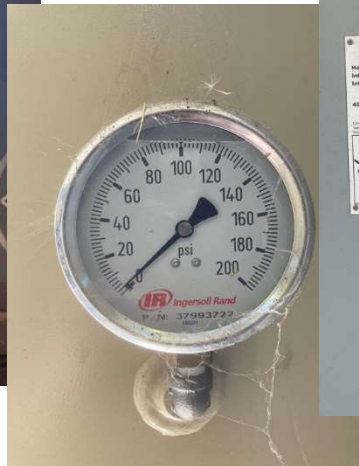
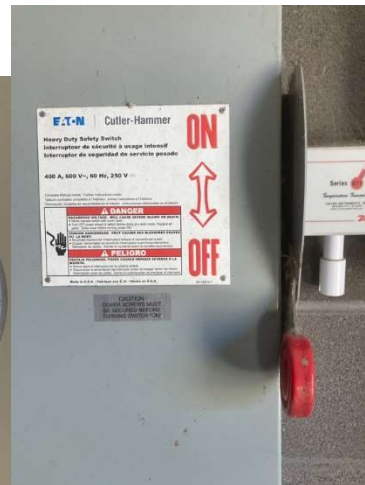
- On October 5th, 2023, the process for compressor was shut down in accordance with Authority Policies and Procedures was begun.
- The newly installed drip legs were released of accumulated water to prevent water freezing in the pressure reducers.
- Water was blown off from the compressor and the regulator tank.
- A new procedure whereby the air discharge valves downstream of the pressure reducers were shut down very slowly while the compressor was still running to shut off the air to the aeration system gradually to prevent a sudden back pressure on the aeration system heads that has caused some of the O-rings to blow out in the past.
- After the valves were shut, the compressor was shut down for the winter at 8:15 am.
