We Need Your Help to Protect Cherry Creek and the Reservoir!

Muller Engineering Company recently completed a stream channel and water quality assessment on Cherry and Piney Creeks (see Figure 2) for CCBWQA that identified serious issues requiring a major capital investment to repair. Key findings include:

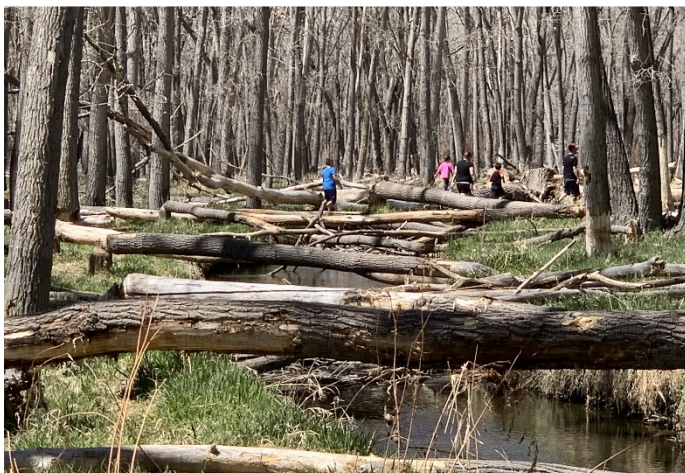
Photo 1 – Cherry Creek in CCSP

Severe erosion (see photos 1 and 2) is occurring in Cherry Creek in CCSP and in Piney Creek immediately upstream. The erosion is threatening the surrounding environment, wildlife corridors, critical infrastructure, and water quality. Additionally, downed trees could become debris in a large flood event potentially impacting the flood control purpose of the Reservoir.

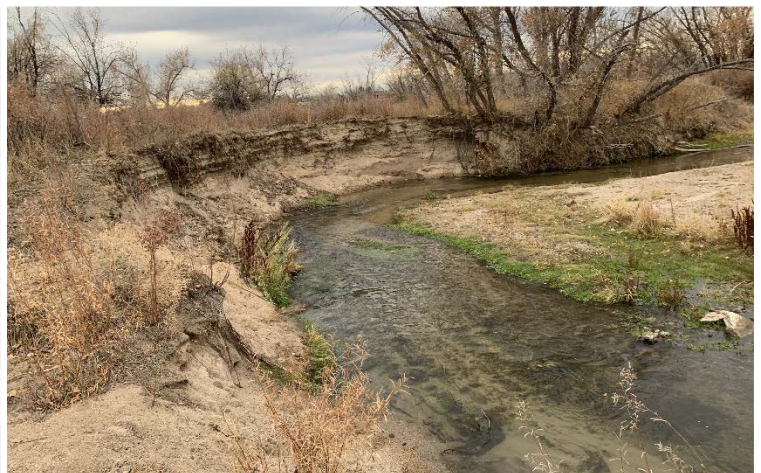
Photo 2 – Cherry Creek upstream of CCSP

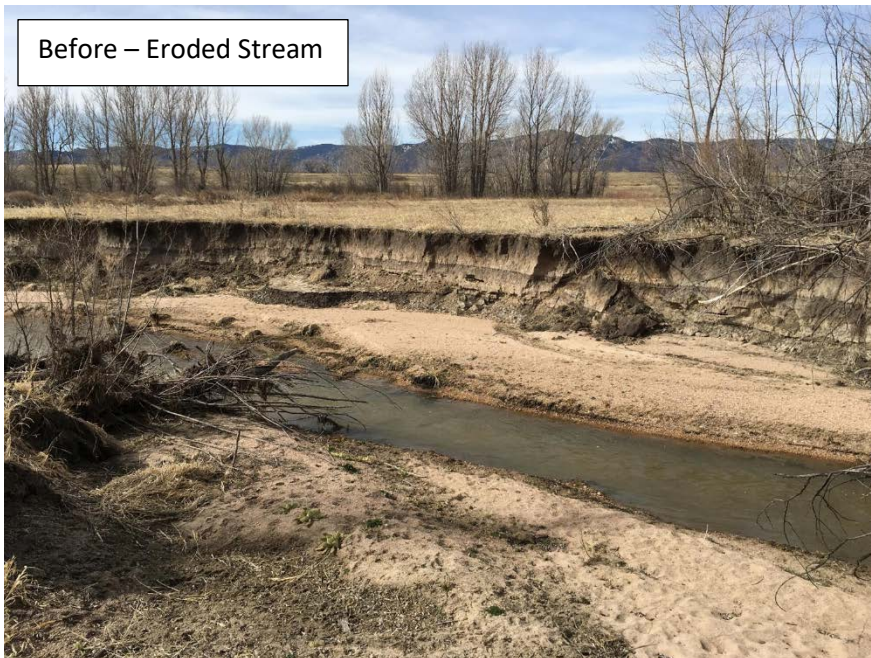
Photo 3 – Example of Similar Degraded in Plum Creek in Chatfield State Park Prior to Stabilization

Because of the high capital cost needed to complete these repairs in a timely manner, CCBWQA and CPW are seeking funding partners to support stream reclamation similar to the example shown in Photos 3 and 4 in Chatfield State Park. In 2023, CCBWQA is preparing an alternatives analysis that will result in a refined plan for reclamation and a refined cost estimate. We are currently identifying partners who may be able to help fund this high priority project.
